DEPARTMENT OF TRANSPORTATION**DIVISION OF ENGINEERING SERVICES**

Quality Assurance and Source Inspection

Contract #: 04-0120F4Cty: SF/ALA Rte: 80 PM: 13.2/13.9File #: 69.15**SOURCE INSPECTION REPORT****Resident Engineer:**Pursell, Gary**Address:** 333 Burma Road**City:** Oakland, CA 94607**Report No:** SIR-000606**Date Inspected:** 10-May-2009**Project Name:** SAS Superstructure**OSM Arrival Time:** 0**Prime Contractor:** American Bridge/Fluor Enterprises, a JV**OSM Departure Time:** 12**Contractor:** Zhenhua Port Machinery Company, Ltd (ZPMC), Changxing Island**Location:** Changxing Dao, Shanghai

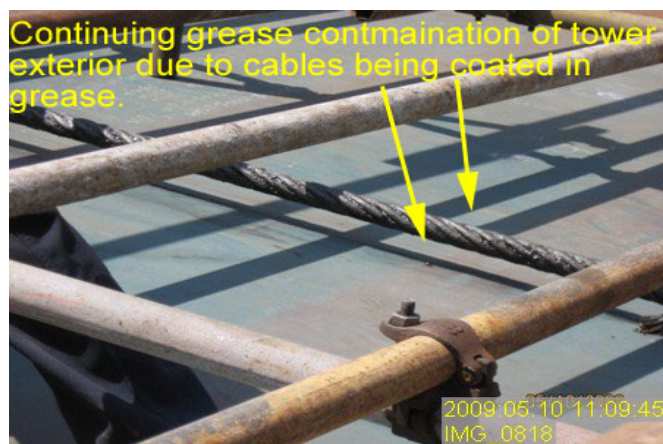
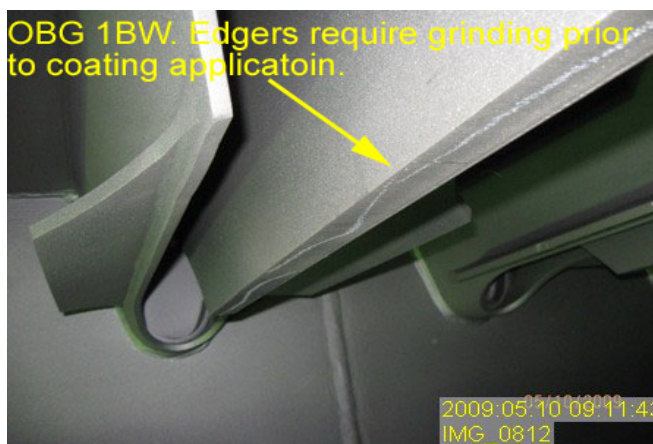
Fabrication on assembled components of the OBG's are not complete. Coating damage requiring re-blast is expected.
